Photovoltaic Array Overheat & Fire Detection

A Research Report on Linear Heat Detection Systems for Overheat and Fire Warning in Photovoltaic Applications

Report No. 366/25-560-1-EN

REPORT
366/25-560-1-ENAbout using Linear Heat Detection systems in PV-
related fires

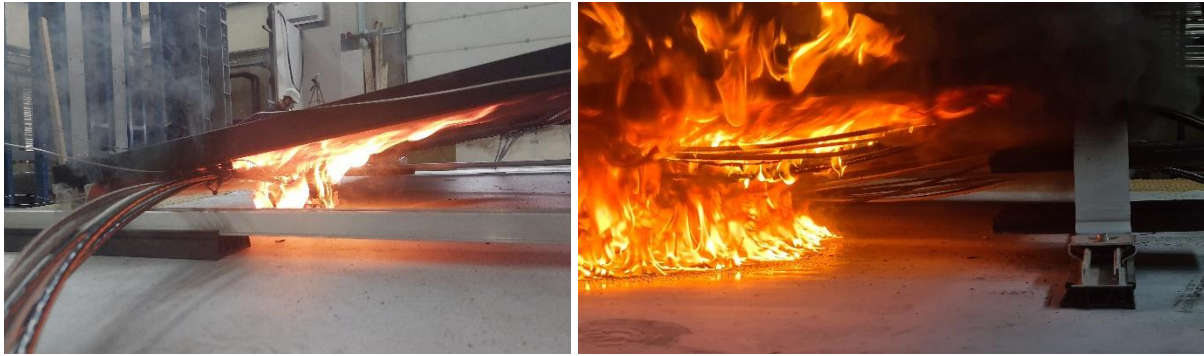
The fire involved detection cables within the first minutes of the test (Figure 13). Delamination of the PV cells in the PV module was observed by minute 3, followed shortly by flames emerging from the top and right sides of the PV module. Around 4.5 min after ignition, detection cables located near the top edge of the specimen released volatile compounds that ignited, producing a distinct jet flame effect with blue and green flames, attributed to the presence of the various chemical components present in the LHD cables. Due to the characteristics of these flames, capturing them on camera was difficult with the available cameras. By minute 8.5, the fire had spread to the far-left edge of the specimen. The intensity of the fire began to decrease after minute 14 and was mainly located on the right side of the sample. At 17 min, the glass of the PV panel broke as shown in Figure 14. No more flames were observed on the roof surface after 22.5 min.

Figure 16 Detection cables on fire 1 min (left) and 6 min (right) after the ignition (FotoPortal (left 050522d-001, right 050522d-002))

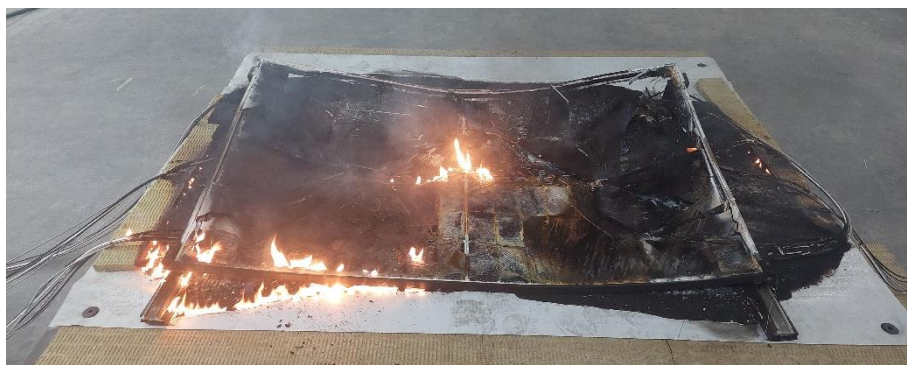
Figure 17 Specimen towards the end of the test (FotoPortal 050522d-003)

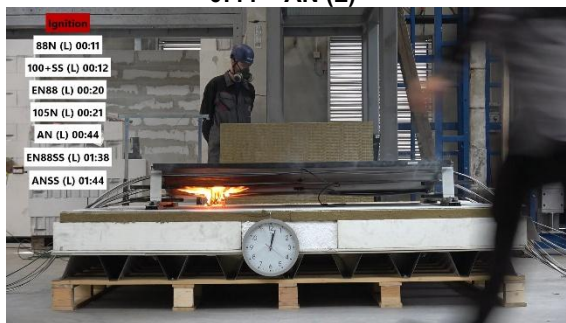
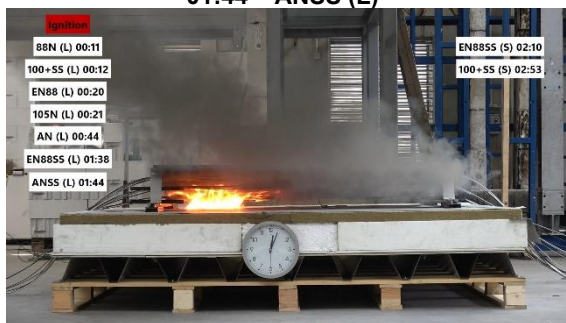
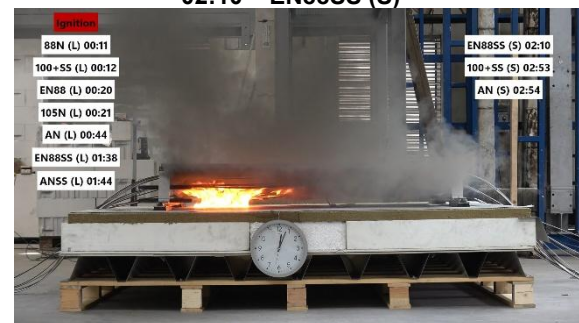
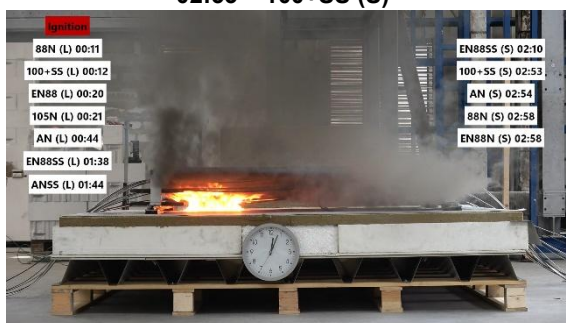
01:44 – ANSS (L)

02:53 – 100+SS (S)

02:54 – AN (S)

02:58 – EN88N (S)

Figure 18 Snapshots from the camera pointed toward the long edge of the specimen (white boxes show type of LHD cables and their detection times). Times are given in min:s. (FotoPortal from 050522d-004 to 050522d-016)

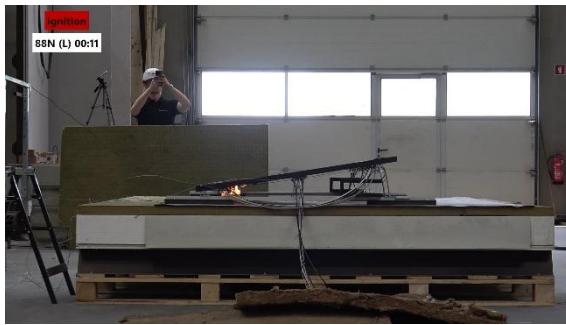
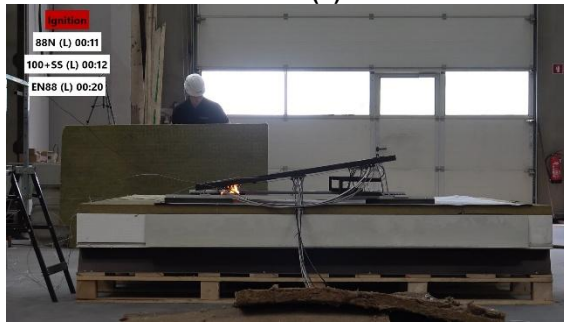
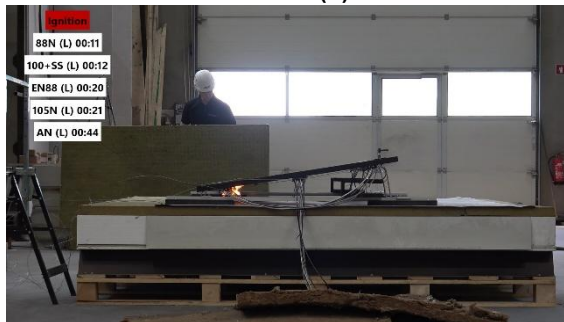
0:12 – 100+SS (L)

0:21 – 105N (L)

0:44- AN (L)

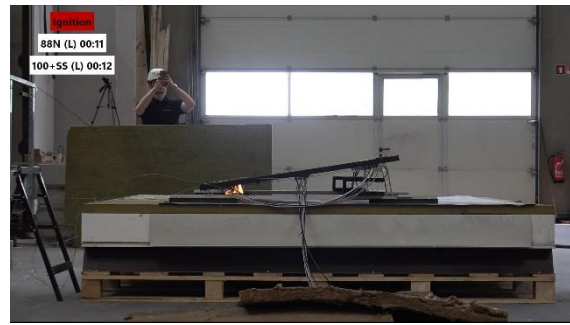
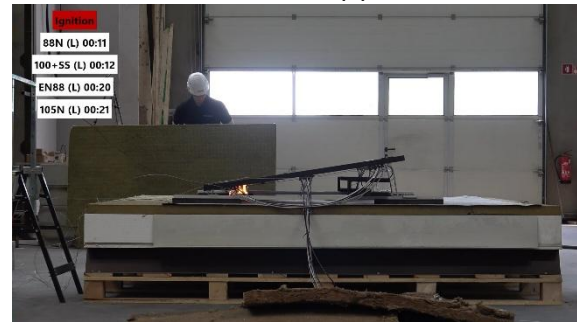
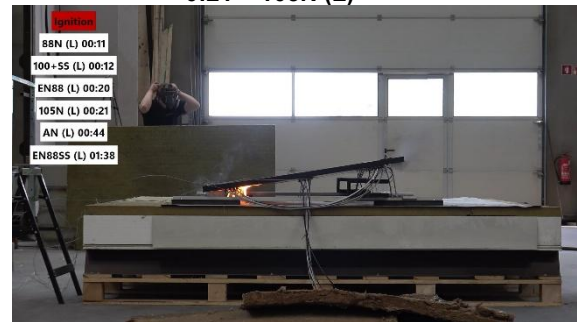
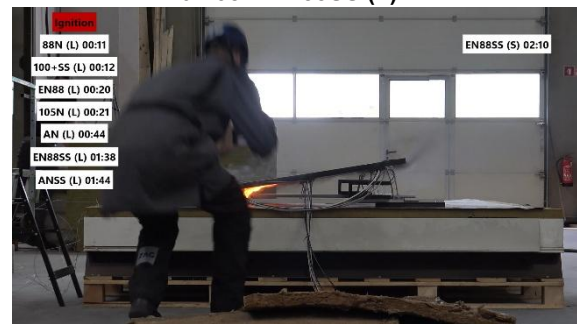
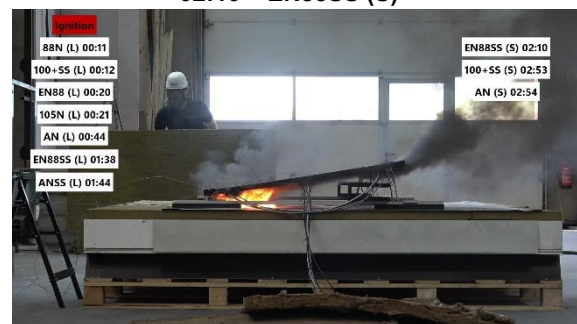
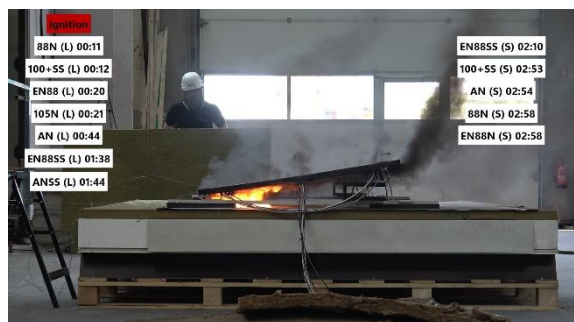
Figure 19 Snapshots from the camera pointed toward the short edge of the specimen (white boxes show type of LHD cables and their detection times). Times are given in min:s. (FotoPortal from 050522d-017 to 050522d-029)

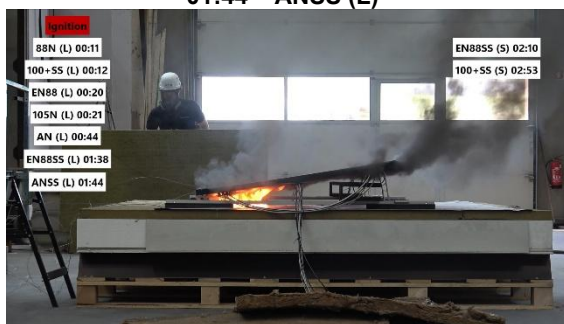
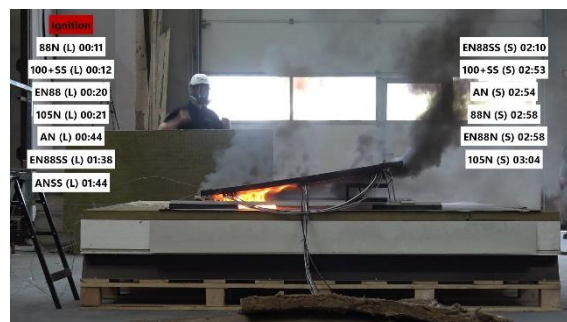
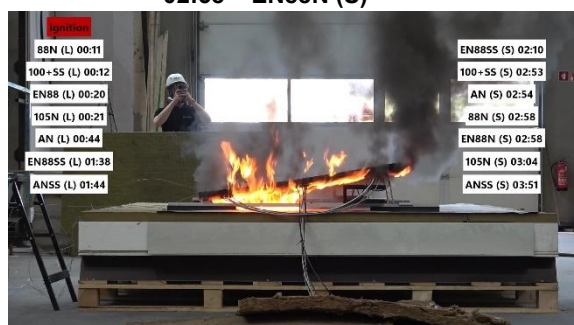
02:53 – 100+SS (S)

**03:04 – 105N (S)**

**03:51 – ANSS (S)**

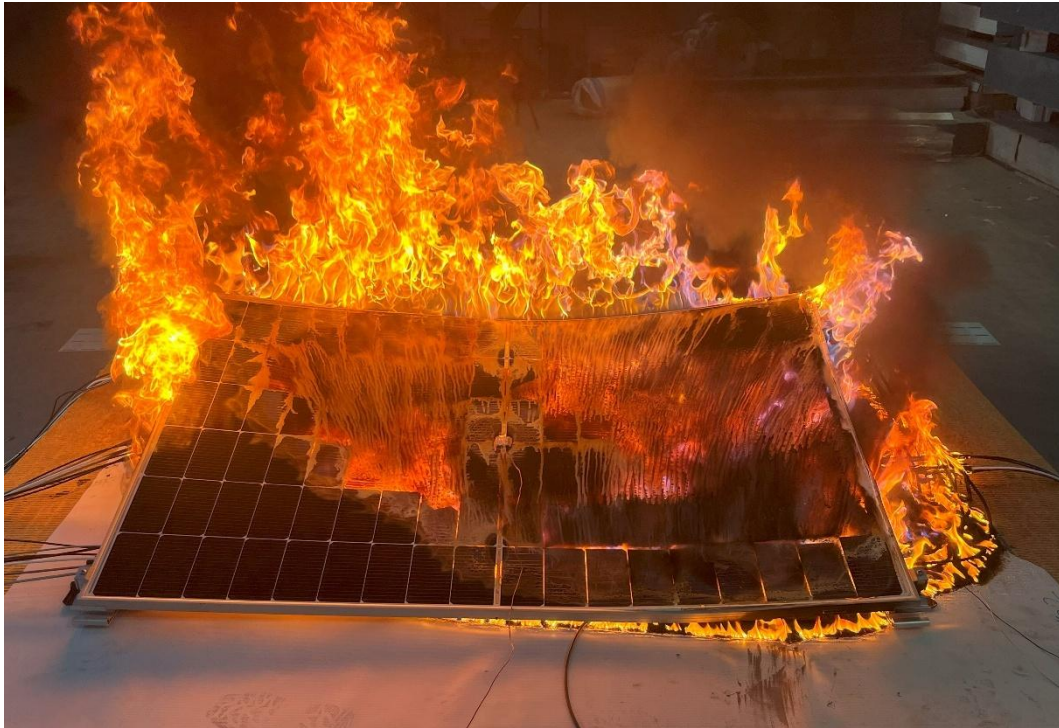
Arc generation was stopped in the 3rd minute of the test, around the same time as flames emerged from the top and right side of the PV module, accompanied by visible delamination of solar cells. By minute 4.5, burning droplets were observed dripping from the cables. At 5 min, the detection cable near the top edge emitted volatile compounds, again creating a jet flame effect with blue and green hues (Figure 20).

Figure 20 PV module engulfed in flame, along with blue flames coming from the cables (top right corner)
(FotoPortal 050522d-030)

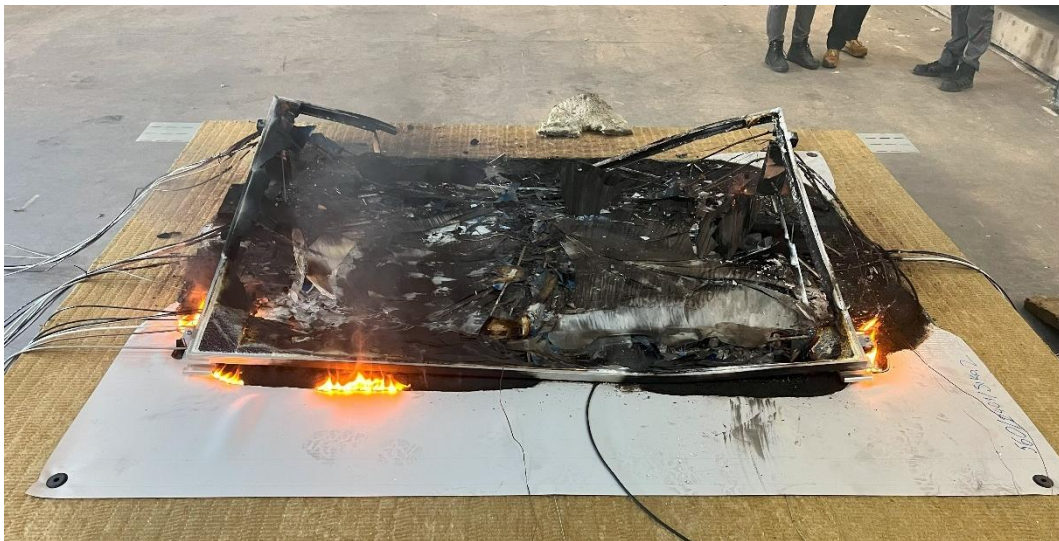
Around 6-7 minutes into the test, the fire reached the far-left edge of the specimen. By minute 9, the fire actively started to subside, and the glass of the PV panel shattered. Shortly after, the flames confined to the polymeric footing of the mounting system and roofing membrane (Figure 21).

Figure 21 Shattered PV panel and flame residues on the roofing membrane (FotoPortal 050522d-031)

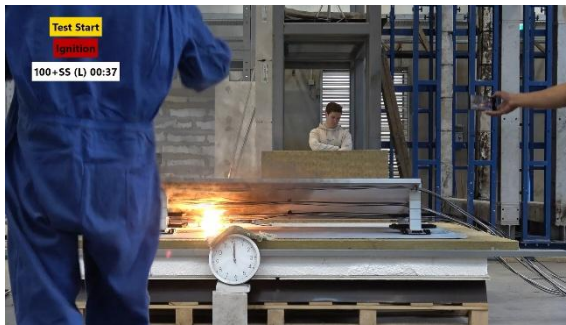
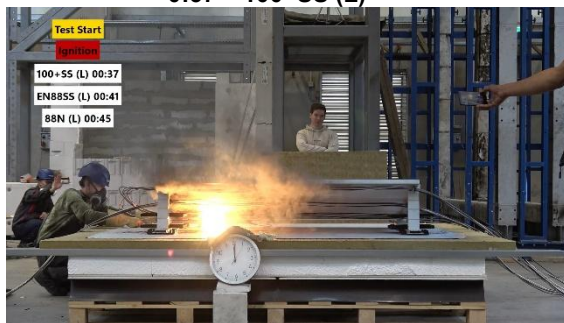
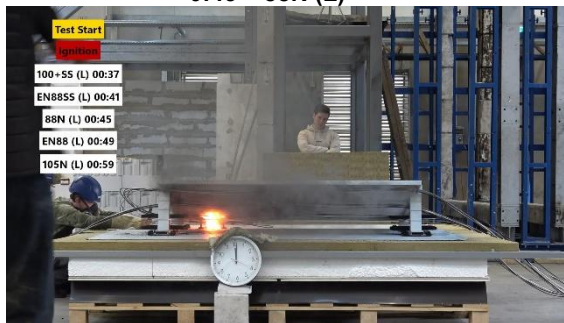
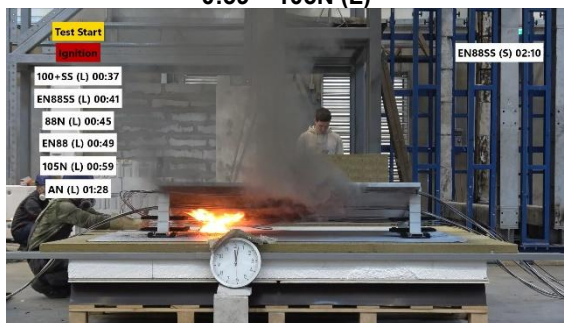
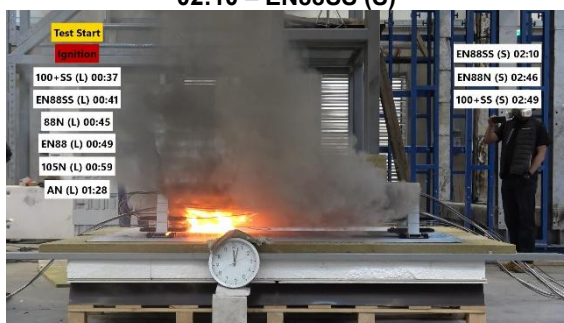
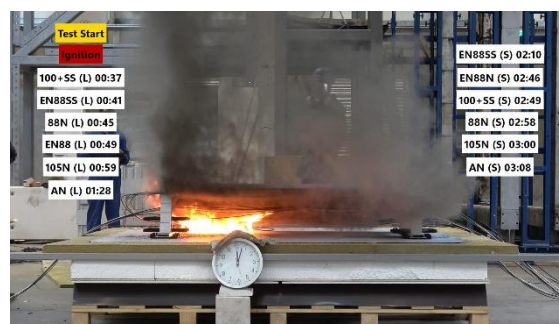
0:37 – 100+SS (L)

0:45 – 88N (L)

0:59 – 105N (L)

02:10 – EN88SS (S)

02:49 – 100+SS (S)

03:08 – AN (S)

Figure 22 Snapshots from the camera pointed toward the long edge of the specimen (white boxes show the type of LHD cables and their detection times). Times are given in min:s. (FotoPortal from 050522d-032 to 050522d-044)

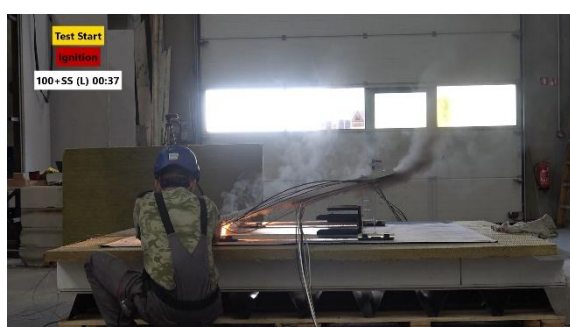
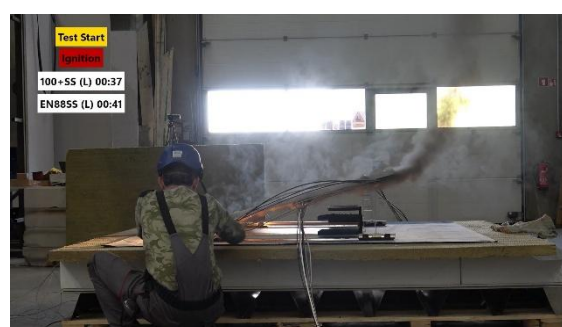
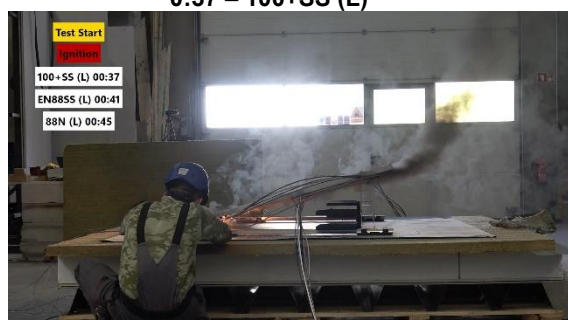
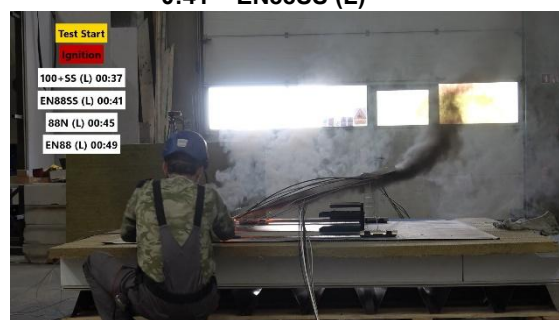
0:37 – 100+SS (L)

0:41 – EN88SS (L)

0:45 – 88N (L)

0:49 – EN88 (L)

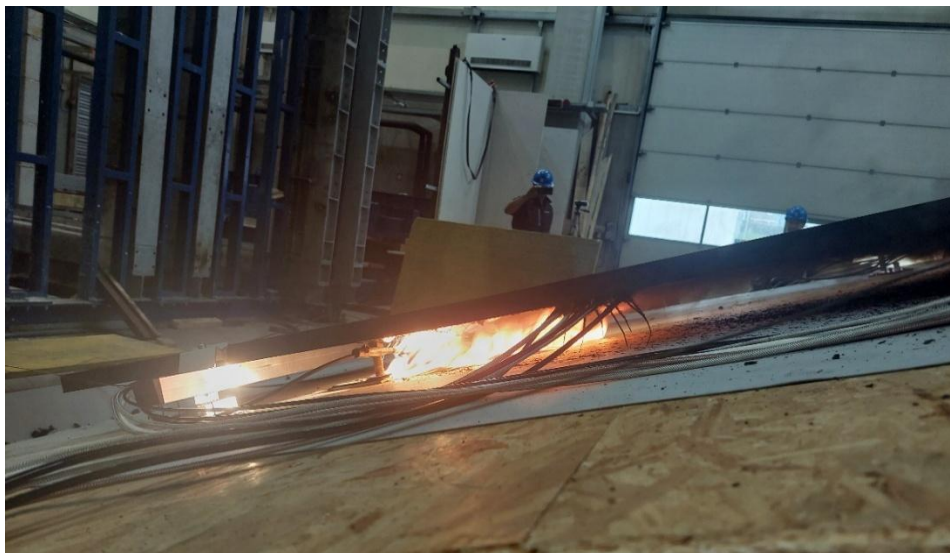
Arc generation stopped after 2 minutes (Figure 24). Shortly after, flames spread upwards and reached the top edge of the PV module by minute 4. At 6 minutes, delamination of solar cells was observed (Figure 25), followed by breakage of the PV glass at minute 11. Two minutes later, the top aluminium edge of the module broke at the centre and began to melt.

Figure 24 The extent of fire on the specimen just after stopping arc generation at 2 min (FotoPortal 050522d-058)

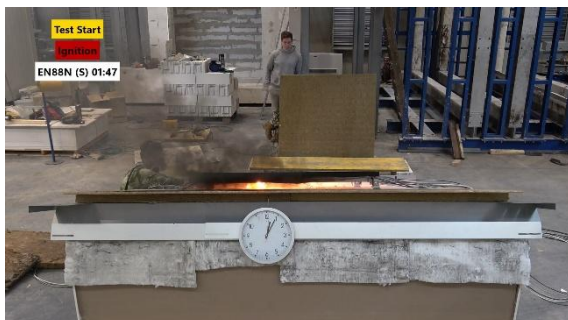
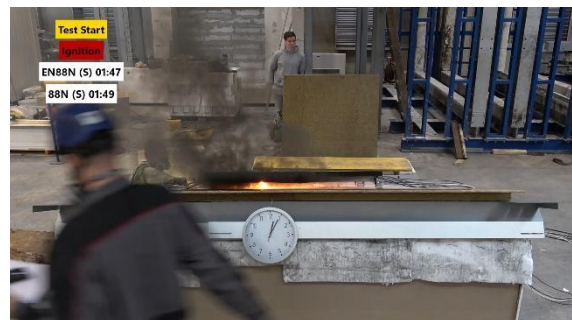
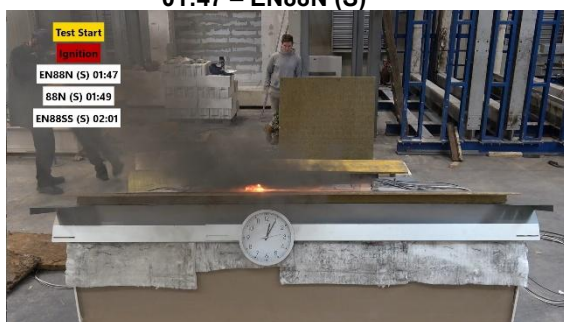
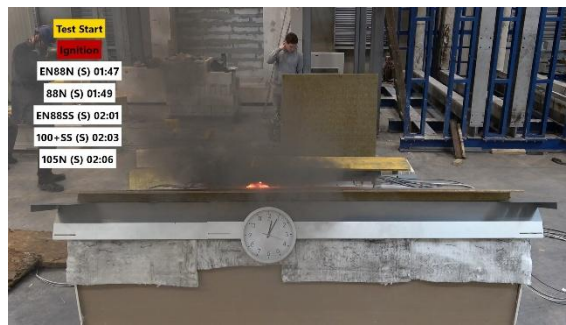
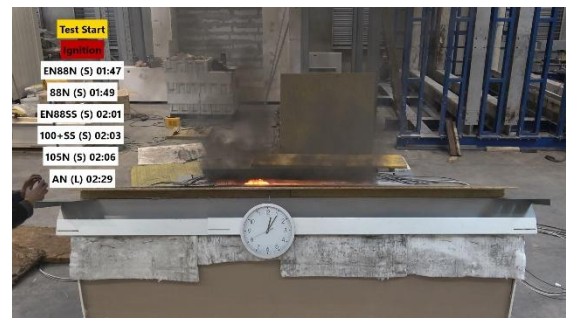
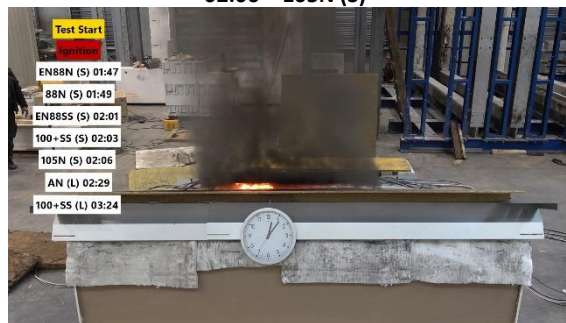
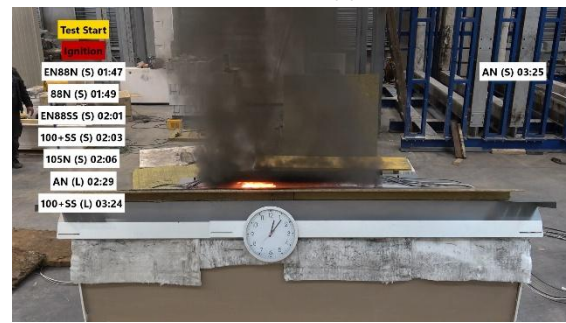
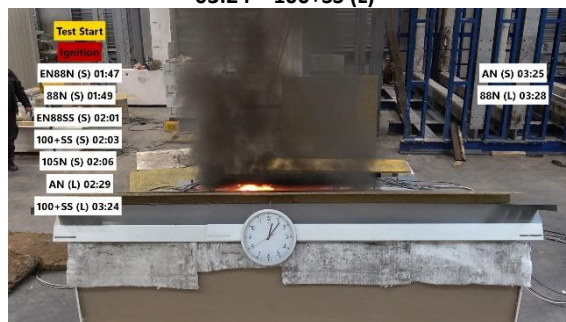
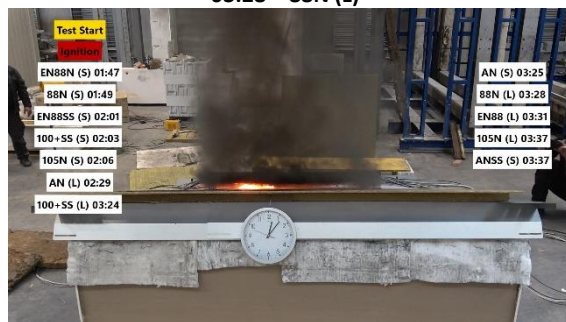
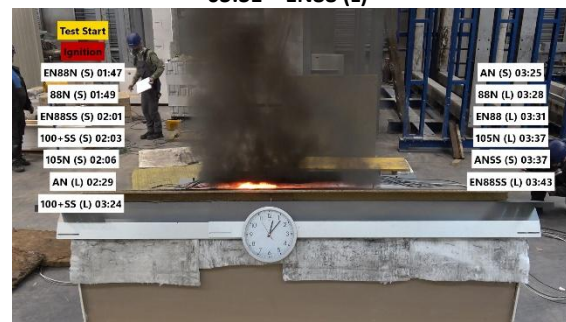
01:47 – EN88N (S)

01:49 – 88N (S)

02:01 – EN88SS (S)

02:06 – 105N (S)

02:29 – AN (L)

03:24 – 100+SS (L)

03:25 – AN (S)

03:28 – 88N (L)

03:37 – ANSS (S)

03:43 – EN88SS (L)

Figure 26 Snapshots from the camera pointed toward the long edge of the specimen (white boxes show the type of LHD cables and their detection times). Times are given in min:s. (FotoPortal from 050522d-060 to 050522d-071)

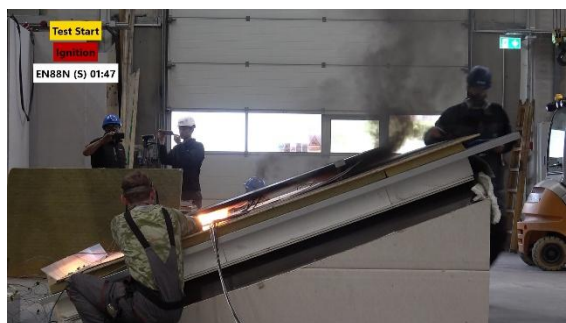
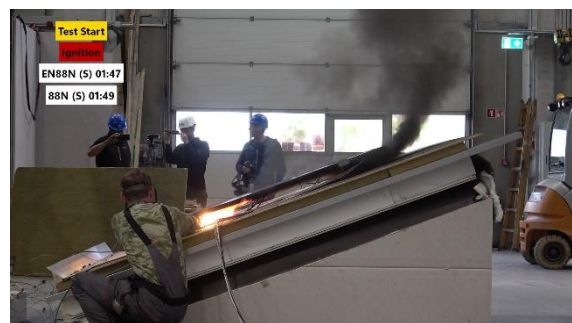
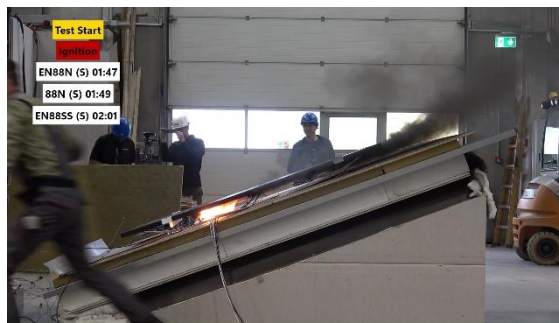
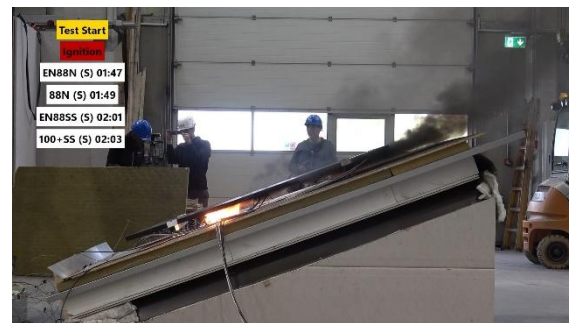
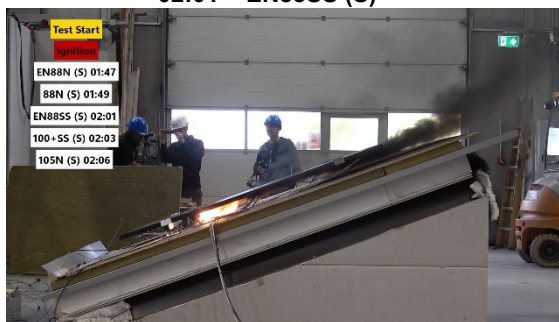
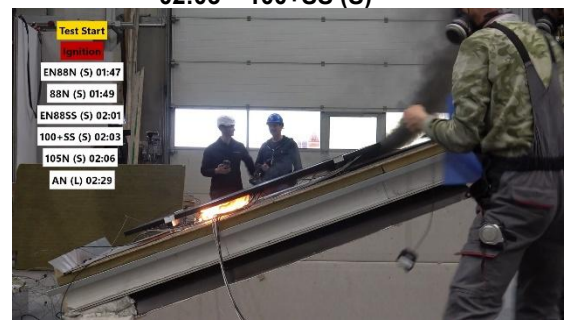
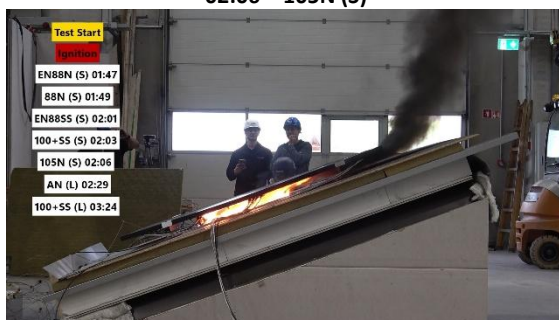
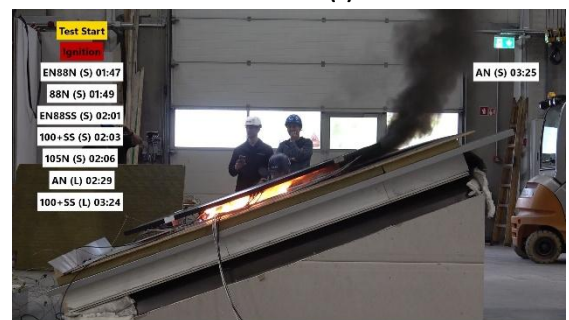
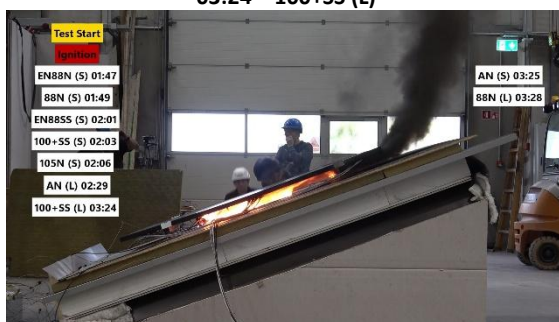
01:47 – EN88N (S)

01:49 – 88N (S)

02:01 – EN88SS (S)

02:03 – 100+SS (S)

02:06 – 105N (S)

02:29 – AN (L)

03:24 – 100+SS (L)

03:25 – AN (S)

03:28 – 88N (L)

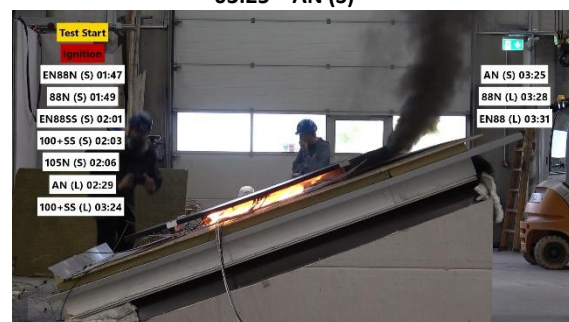
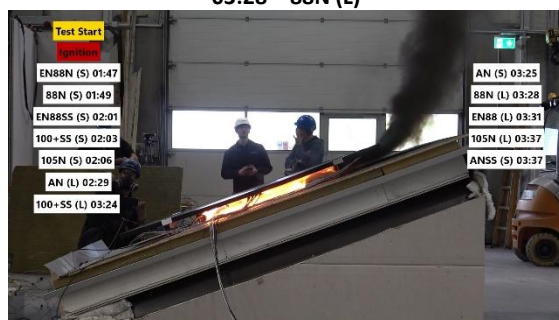
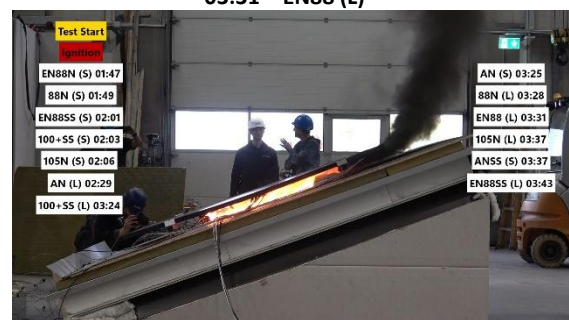
Figure 27 Snapshots from the camera pointed toward the short edge of the specimen (white boxes show the type of LHD cables and their detection times). Times are given in min:s. (FotoPortal from 050522d-072 to 050522d-083)

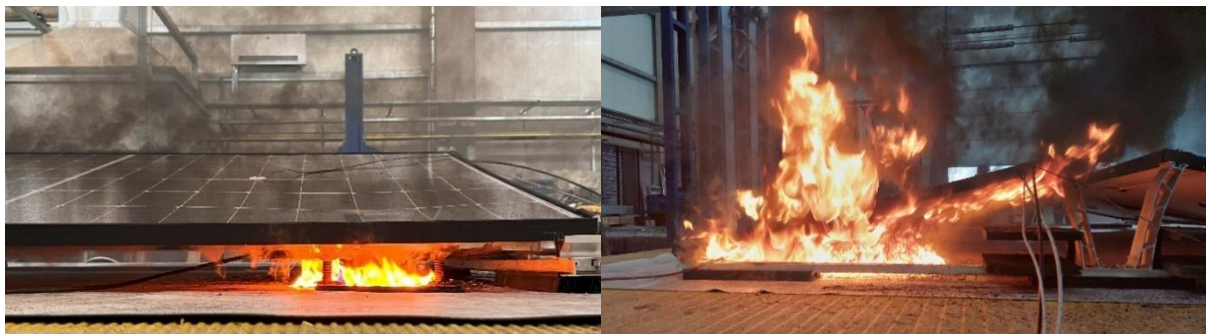
Arc generation stopped after 3 minutes. By minute 5, flames had emerged from the right edge of the first PV module, and shortly after, at minute 6, from its top edge as well (Figure 28). Around minute 6.5, burning droplets falling from the wires were observed. At minute 8, the fire reached the intersection between the third and fourth PV modules, then spread beneath the third module by minute 9 and continued under the fourth by minute 10 (Figure 29).

Figure 28 Flame spread over LHD system after 5-6 min: front (left) and side (right) view (FotoPortal (left 050522d-084, right 050522d-085))

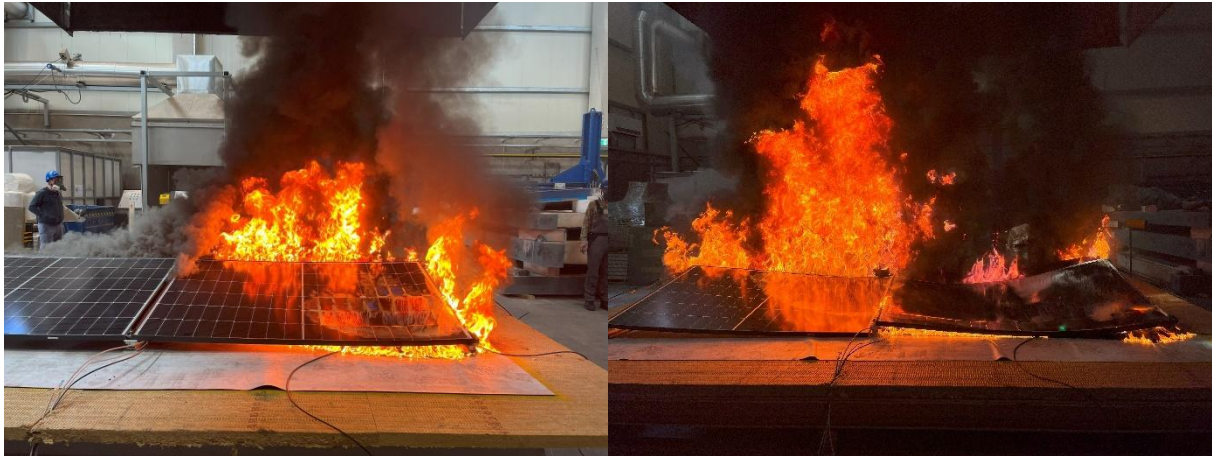
Figure 29 Flame spread over the first PV module (left) and towards the third and fourth modules (right), 8 minutes after ignition (FotoPortal (left 050522d-086, right 050522d-087))

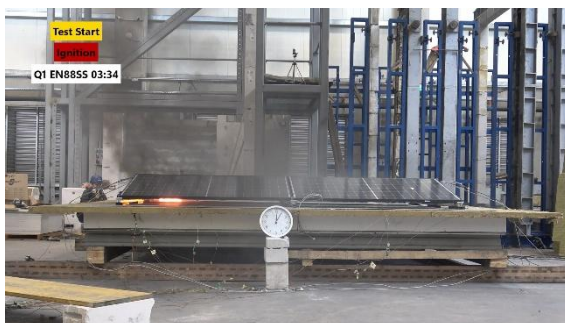
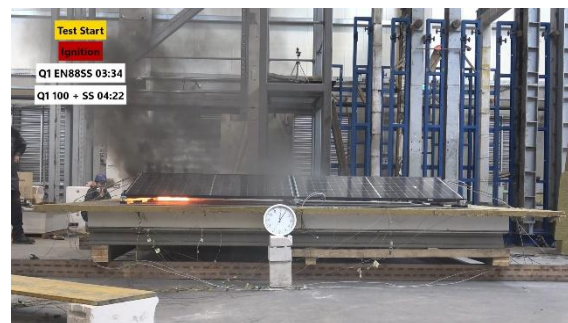
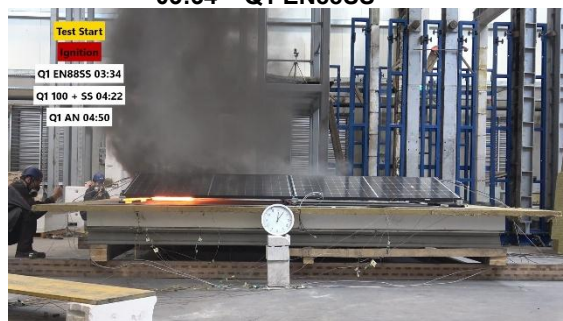
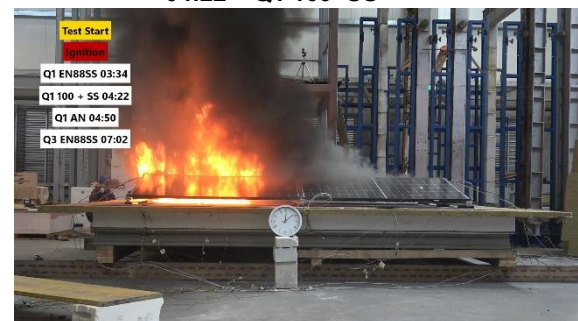
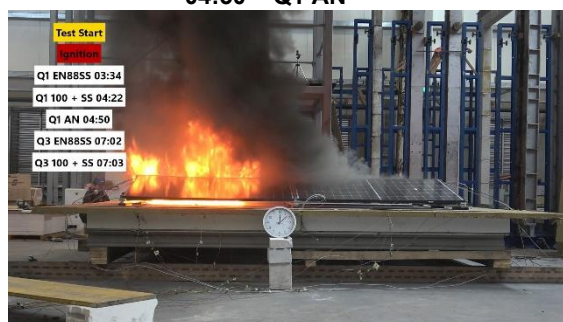
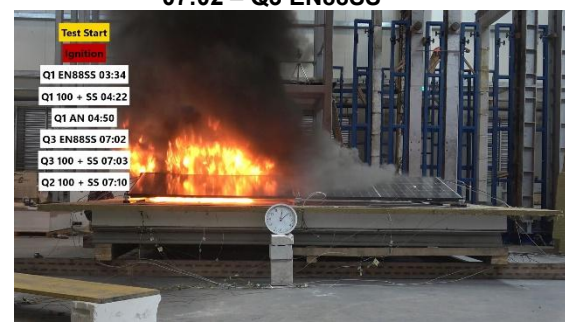
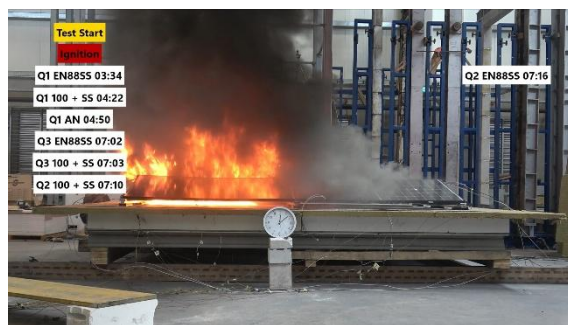
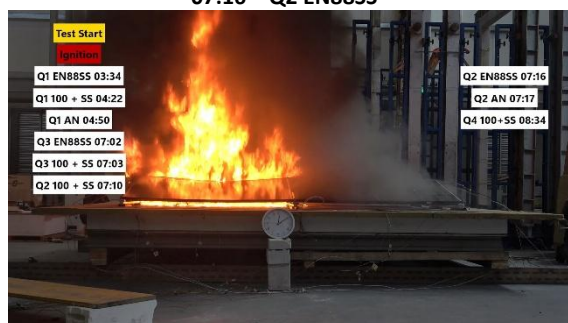
Figure 30 Snapshots from the camera pointed toward the long edge of the specimen (white boxes show the type of LHD cables and their detection times). Times are given in min:s. (FotoPortal from 050522d-088 to 050522d-098)

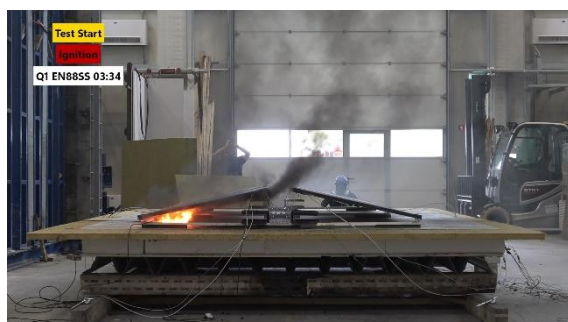
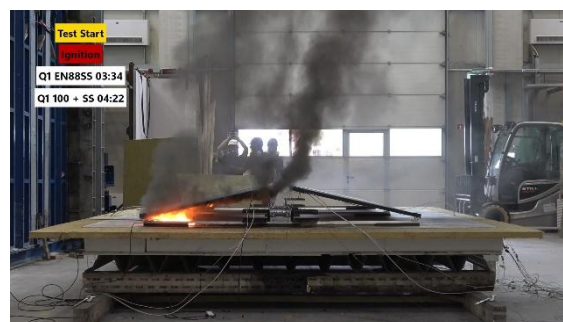
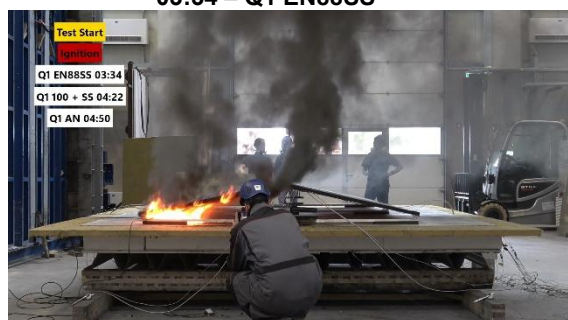
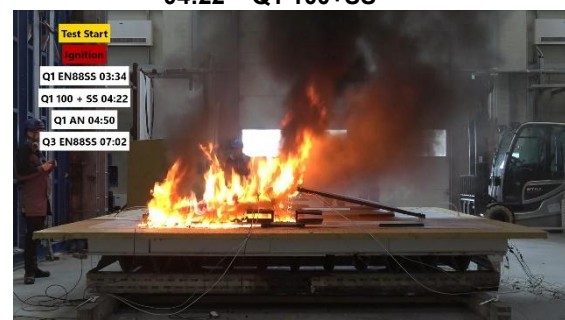
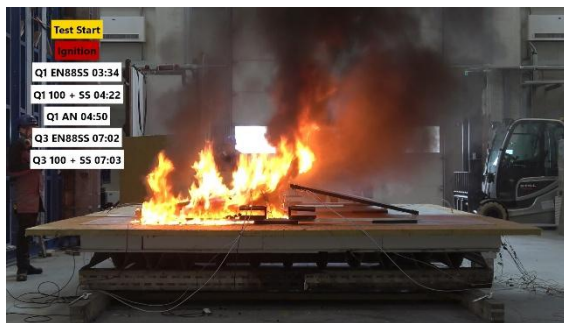
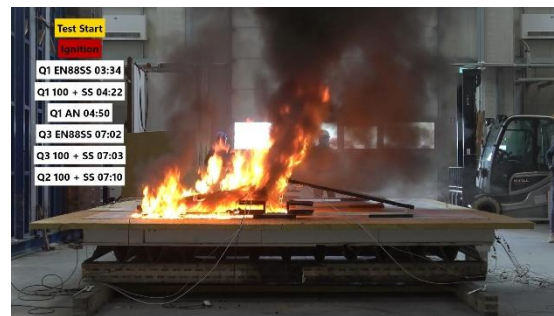
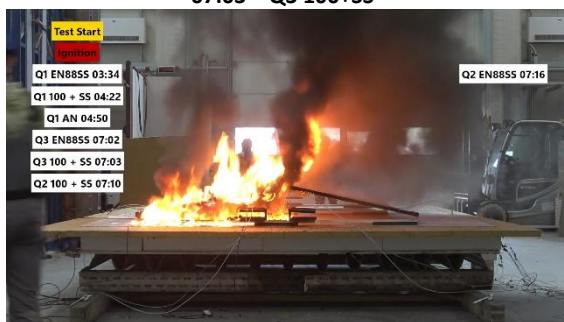
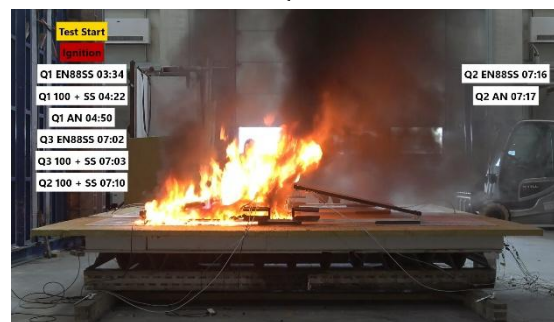
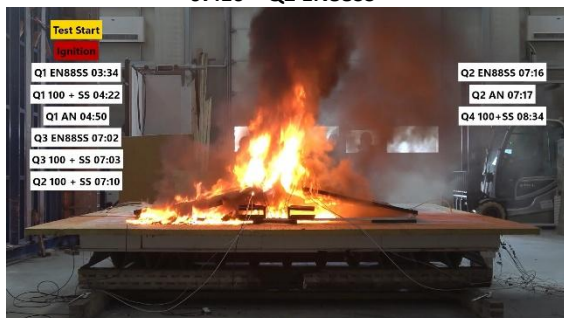
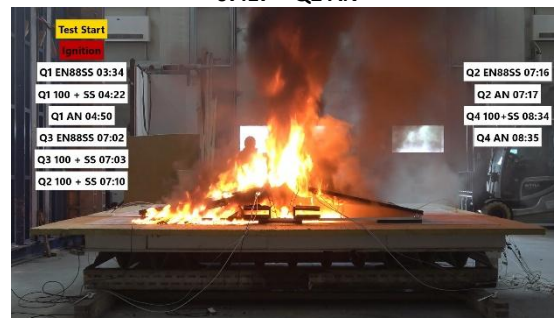
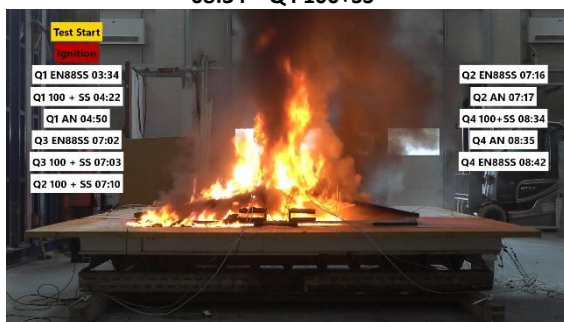
Figure 31 Snapshots from the camera pointed toward the short edge of the specimen (white boxes show the type of LHD cables and their detection times). Times are given in min:s. (FotoPortal from 050522d-099 to 050522d-109)

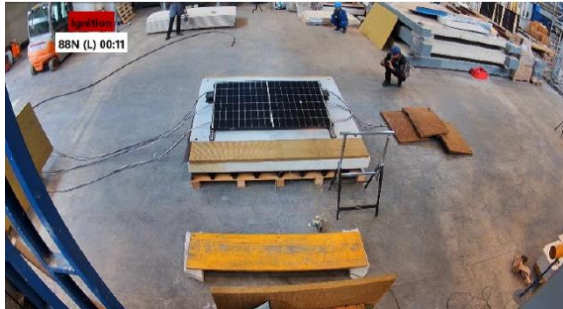
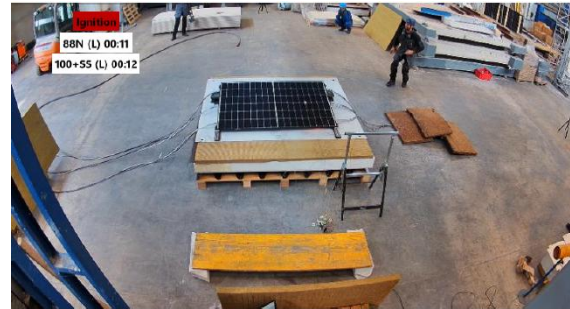
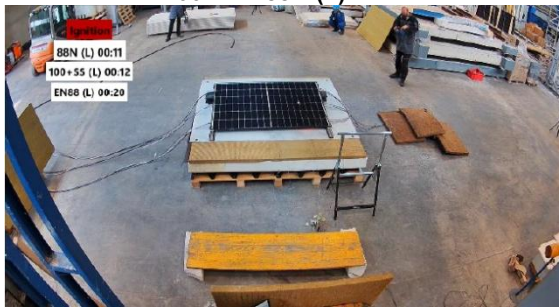
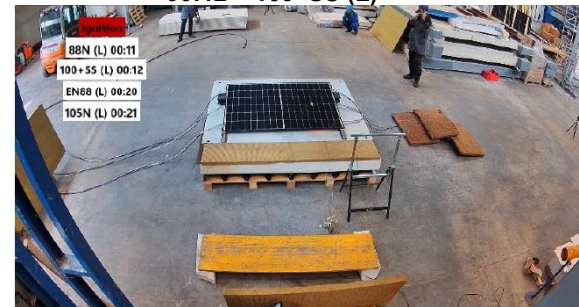
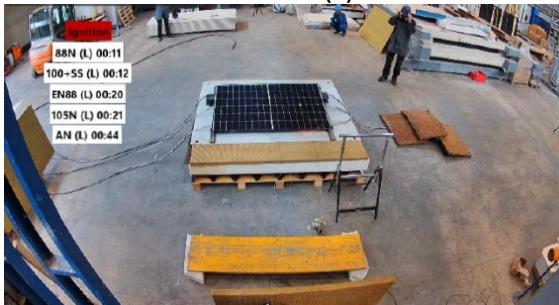
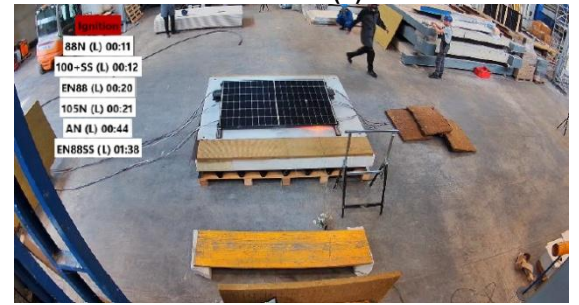
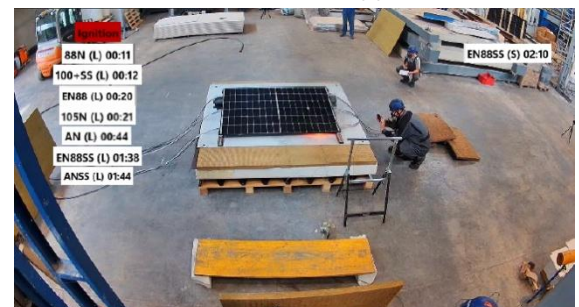
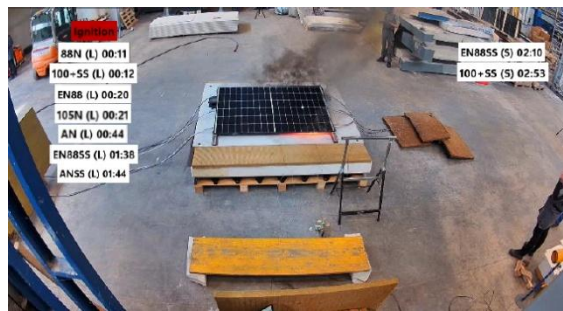
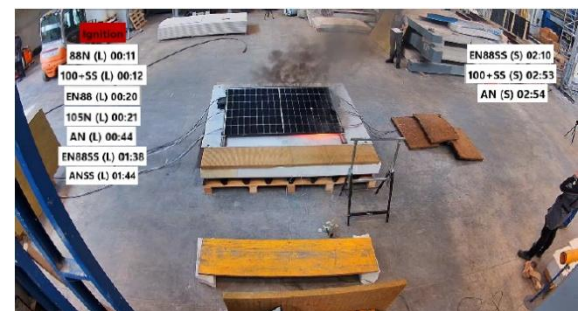
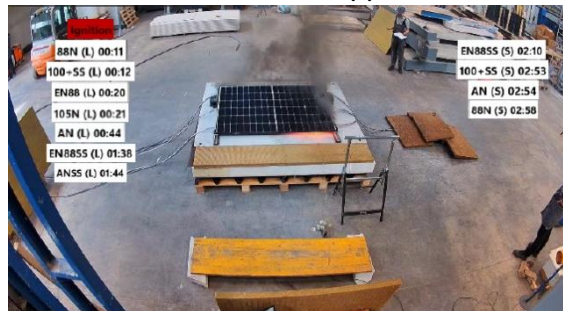
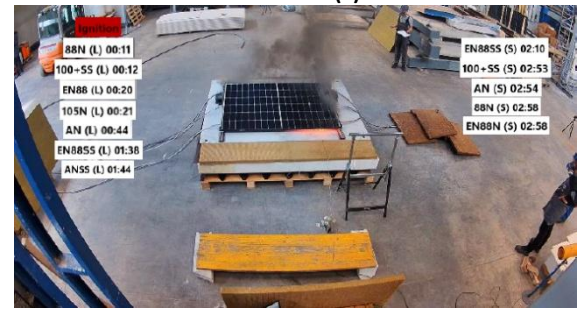
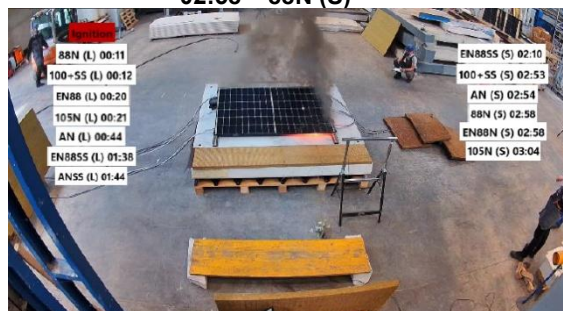
Figure 32 Aerial camera snapshots of LHD-1 during alarm activation (white boxes show the type of LHD cables and their detection times). Times are given in min:s. (FotoPortal from 050522d-110 to 050522d-123)

This section presents aerial images of the test setup. These visuals complement the ground-level camera observations by offering a broader spatial overview of fire development and the positioning of the LHD cables. Aerial footage is included for LHD-1, LHD-3, and LHD-4 and presented in Figure 32, Figure 33 and Figure 34, respectively. Due to limitations during data collection, aerial material for LHD-2 is not available.

The results confirm that early detection depends on both the installation type of the cables and their position relative to the ignition source. In LHD-1, where ignition occurred directly beneath the long cable run, the 88N triggered an alarm in just 11 seconds, representing the fastest detection observed across all tests. Other cables, such as EN88, 105N, 100+SS, and AN, also responded in under a minute, particularly in the 'long' configuration, demonstrating effective early warning on flat roofs under wood crib ignition.

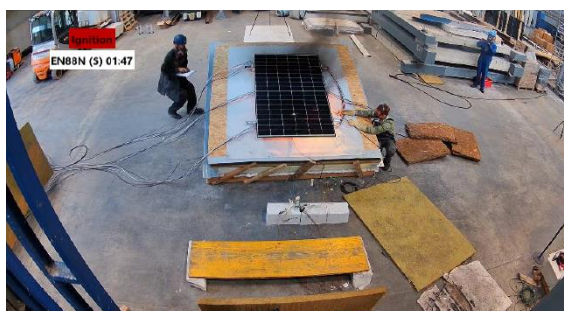
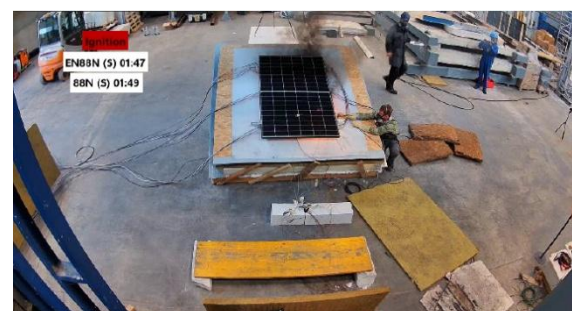
Figure 33 Aerial camera snapshots of LHD-3 during alarm activation (white boxes show the type of LHD cables and their detection times). Times are given in min:s. (FotoPortal from 050522d-124 to 050522d-137)

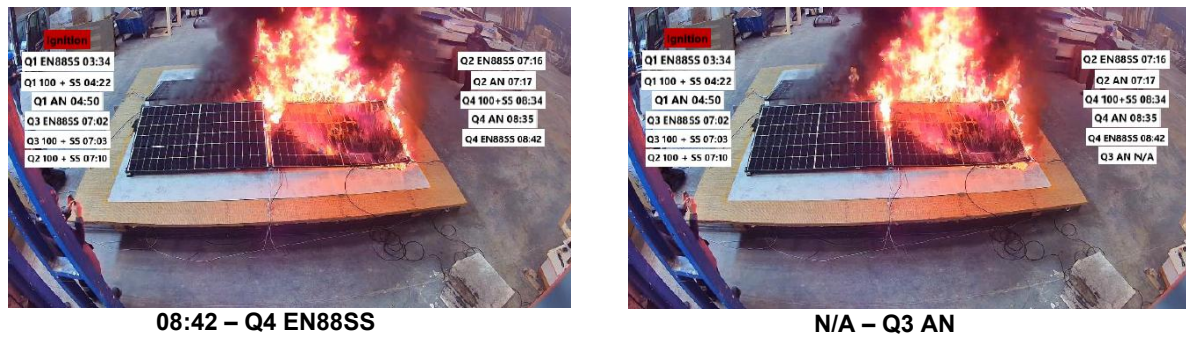
Figure 34 Aerial camera snapshots of LHD-4 during alarm activation (white boxes show the type of LHD cables and their detection times). Times are given in min:s. (FotoPortal from 050522d-138 to 050522d-149)
